QUARTERLY JOURNAL OF
INDIAN SOCIETY
OF
STRUCTURAL ENGINEERS

VOLUME 15-1

Jan-Feb-Mar 2013

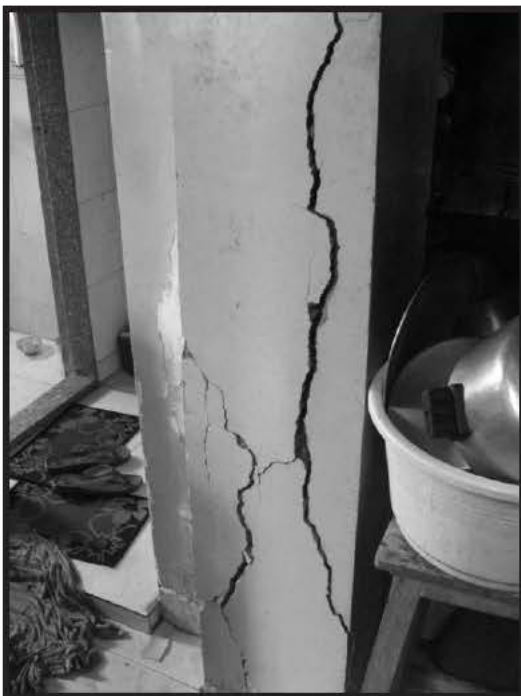
Indian Society of Structural Engineers (ISSE) has evolved the General Guidelines for Structural Audit Report as given below, which will give the purpose for which the audit is to be conducted. It is more appropriate to term it as **“condition survey report” rather than Structural Audit.**

Date of Inspection	
Date of previous inspection report	
Name of Building	
Year of construction of building	
Drawings available Copy of structural drawing / Architectural is available / not available	
Mode of use Office / Residential / commercial.	
Type of structure RCC framed / Steel frame / load bearing masonry	
No. of floors for building / Wings / Flats	
No. Of lifts	
Type of underground, overhead water tanks.	
Last repairs and painting done.	Structural repair: Terrace water proofing External plaster Plumbing and drainage Pavement around bldg.
Any immediate repairs required.	No/Yes (As mentioned)
Present condition of the building.	Satisfactory Not Satisfactory – Minor damage / Major Damage / Severe damage Dilapidated / Unsafe

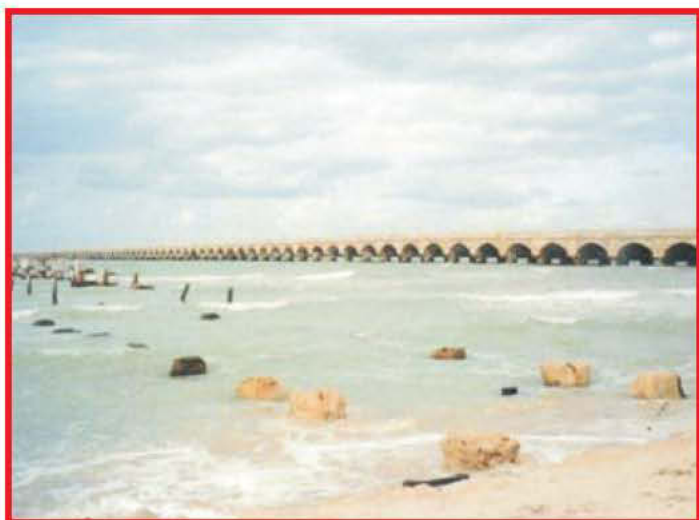
Whilst the premature failure of major highway bridges in Northern Europe and North America can be partly attributed to the use of de-icing salts in winter months, the similar effects of carbonation and chloride ingress in industrial areas and marine environments respectively should not be overlooked.

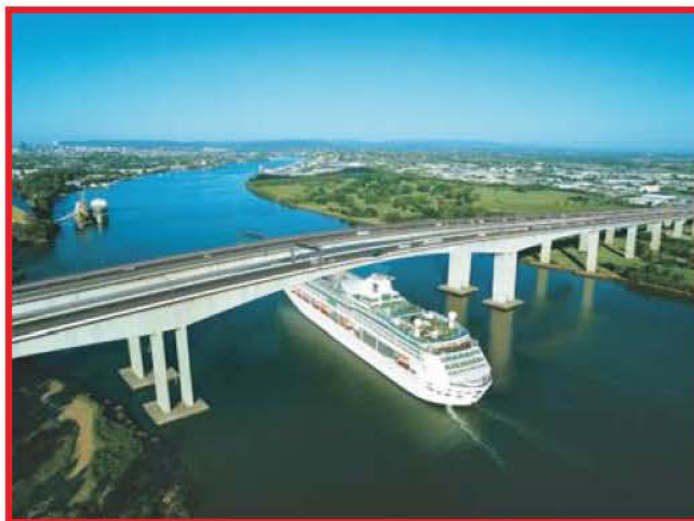
The photograph alongside is the largest road and bridge project across the Brisbane river in Australia's Queensland history. Looking to the future, the new bridge is having a design life of 300 years. To ensure such a long lifespan, the bridge design specifies stainless steel reinforcement bar (rebar for short) in the most critical bridge structures: the splash zones of the two main river pylons.

While searching for a stainless rebar supplier for a product in the austenitic grade EN 1.4404 (ASTM 316L), using duplex stainless steel of grade LDX 2101® was suggested because the corrosion resistance of this duplex grade is close to that of 1.4404. Duplex stainless steel had never been used as reinforcing bars before, not to speak of LDX 2101®. The test results prove that LDX 2101® withstands a high corrosion environment. As a result, the second Gateway Bridge used LDX 2101® rebars and project is completed in 2011.

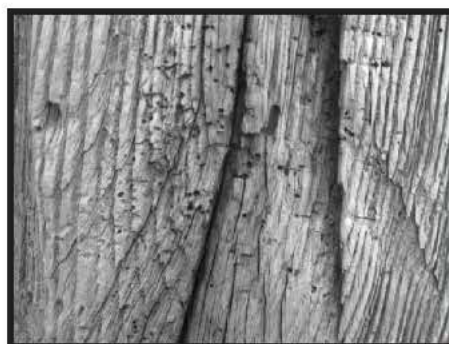
Fig. 1. Damage To Wood Caused By The Sun

Ultra Violet light is particularly damaging to organic materials such as wood, textiles, pigments etc and it causes colors to fade and surface to become brittle.

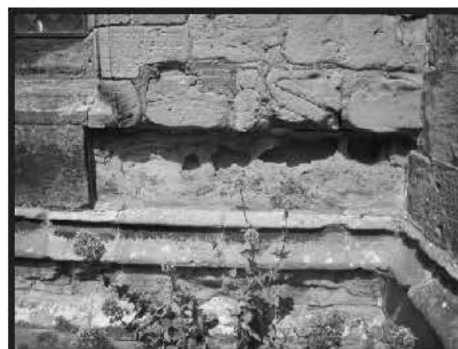
Fig. 2. Damaged Stonework Caused By Combination Of Factors - Dust Particle Erosion, Soft Or Poor Quality Stone, Heat & Wind

• Wind - (Fig. 2.)

Wind can exert a strong directional force. The exposed side of the structure can be subjected to pushing action while the protected side can experience suction and the towering structures deflect under wind pressure. Wind exacerbates the general external erosion of most building materials. Roof coverings can be lifted up in high wind. Hard grit particles can be driven into soft stone and brick pock ets, boring holes into them by action of the wind rotating the particles or scouring their surfaces.

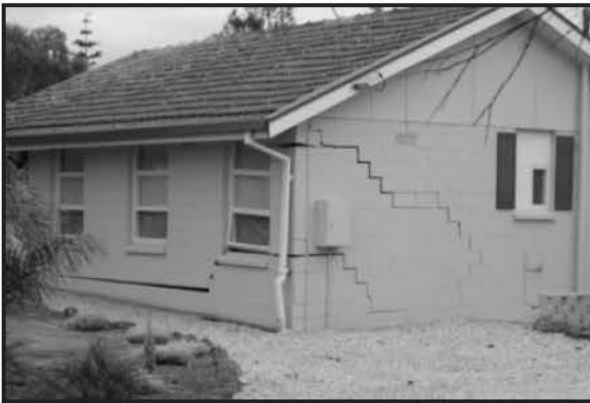
Fig. 3. Failure Of Structure Due To Settlement In Foundation

1. Subsidence or Settlement (due to consolidation or collapse of the soils below the foundations).
2. Shrink -Swell effects (resulting from the wetting or drying of clayey soils that causes the clay to shrink when dried or swell when wetted up. Leaking drains or trees can contribute to this effect).
3. Ground Instability (due to slope movement).
4. Bearing Capacity Failure (due to inadequate strength in the foundation soils).
5. Liquefaction (of loose sands induced by earthquakes).

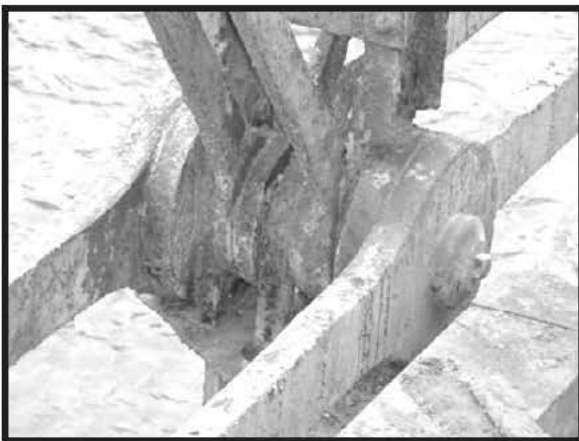
Fig. 4. Corrosion Of Structural Steel

Corrosion of steel occurs due to oxidation and it results in to loss of cross section, strength and ductility.

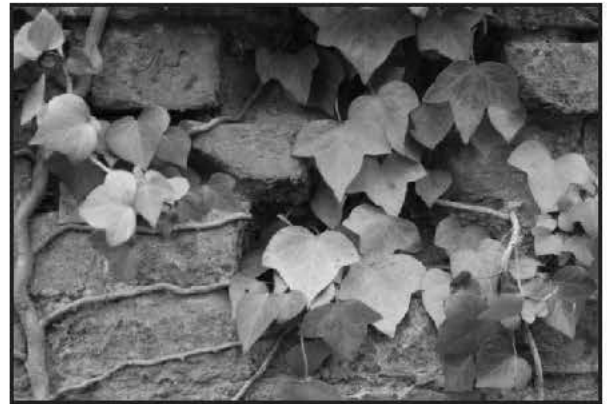
Fig. 5. Ivy Growing On Historic Brickwork

Creeping plants can damage masonry by driving bullet-headed root into crumbling masonry causing disintegration of the material . If forcibly removed it can

pull off a weak surface of brickwork or plaster . The presence of plants growing in a wall is usually in indication of decayed mortar and excess moisture.

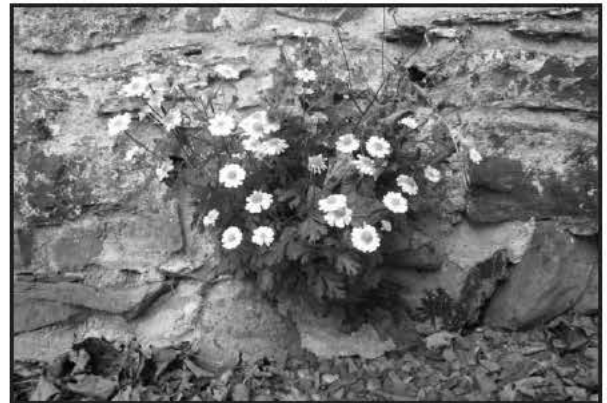
Fig. 6. Daisies Growing In An Area Of Damaged Mortar On A Historic Wall

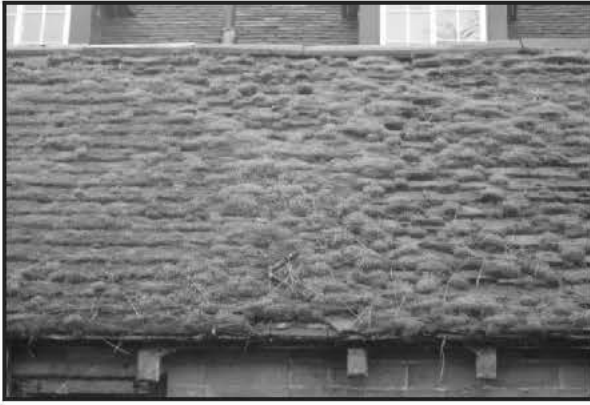
Fig. 7. Moss Damages Roof Due To Its Weight, Water Retention & Lifting Of Tiles

Bacteria, lichens produce acids which react chemically with the building materials. Algae, moss and lichens produce humus in which larger and more damaging plants can grow. Fungi, mildew, moulds and yeasts do not need sunlight for growth. Wood is particularly at risk from dry and wet rot fungus. Fungicides and weed killers can damage the building materials.

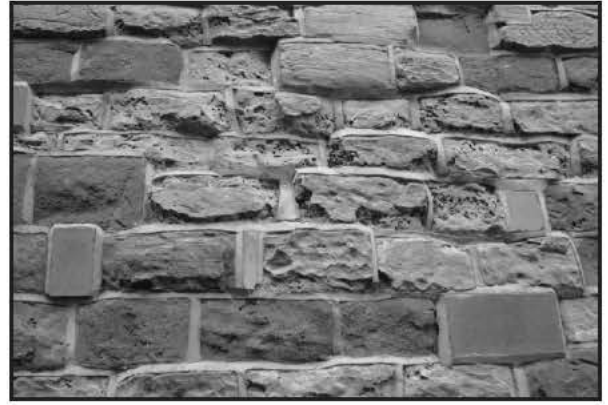
Fig. 10. Damage To A Historic Wall Caused By Masonry Bees, An Inappropriate Pointing Style And Hard Cement Mortar

Insects like woodworm, termite etc attack organic materials such as wood. Masonry bees burrow in soft stone, weak bricks and crumbling mortar joints.

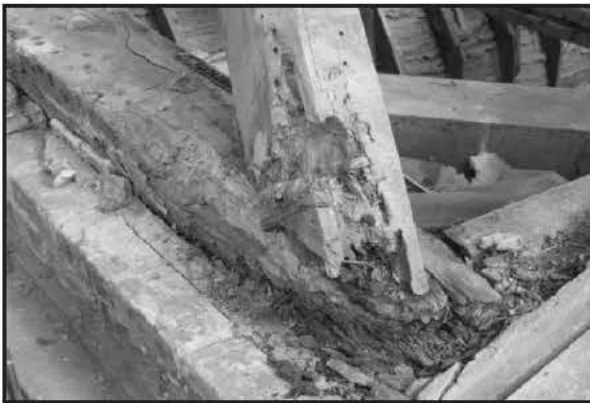
fig. 8. Fungus Attack Causing Brown Rot Of The Roof Rafter

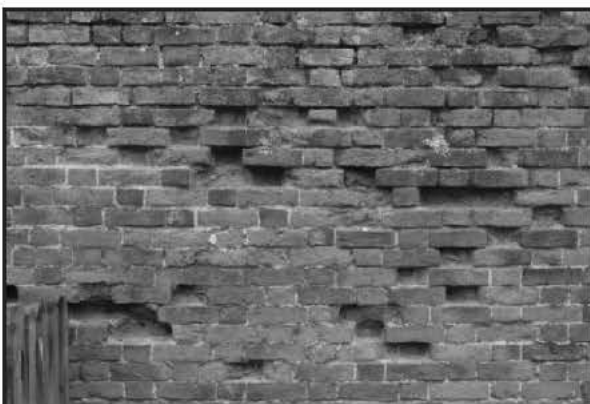
Fig. 9. Ivy And Masonry Bee Damage The Historic Brickwork

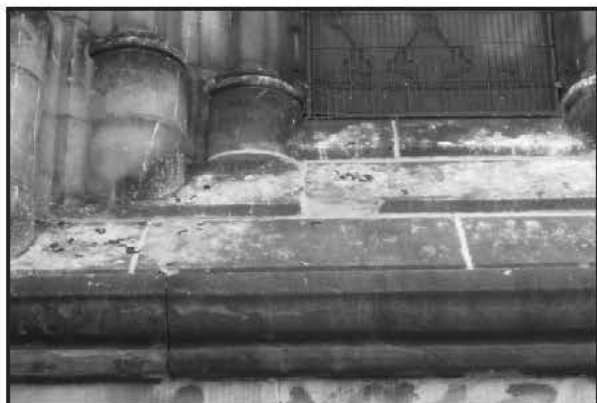
Fig. 13. Bird Droppings - Heavily Soiled Stonework

Bird droppings can be highly corrosive to building materials and a health hazards to people.

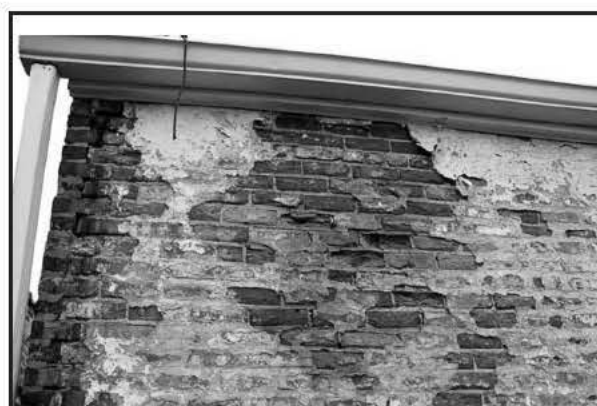
Fig. 14. Deterioration Of Brick Masonry

Natural weathering causes stone to deteriorate over many thousands of years and bricks over several hundred years. This process is accelerated by pollutants released into the atmosphere such as oxides, carbon dioxide, nitrogen, sulphates, chlorides etc, combined with moisture in atmosphere produce a corrosive acidic mixtures.

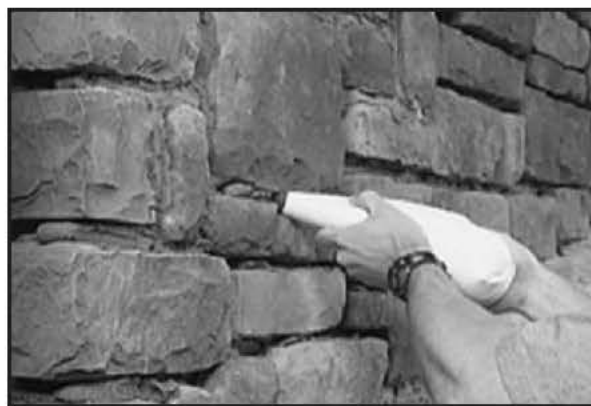
Fig. 15. Deterioration Of Stone Masonry

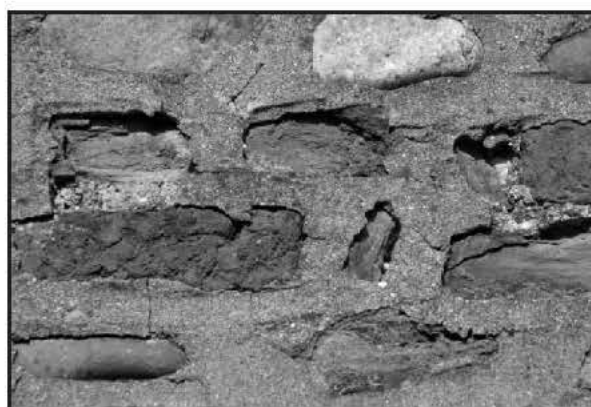
Fig. 16. Spalling Of Stone In A Historic Wall Due To The Inappropriate Use Of Hard Cement Mortar

Using modern cement mortar to repoint old walls, chemically injected damp proof courses, application of water repellent covering to exterior walls and renders, use of materials having inconsistent strength and modulus of elasticity compared to existing members.

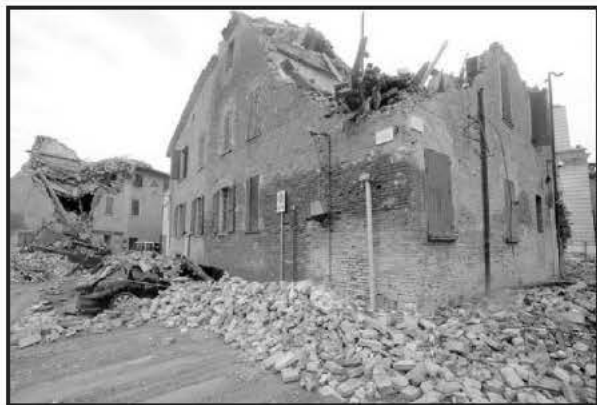
Fig. 17. Earthquake Affected Brick Masonry Structure

Earthquakes can cause severe damage and even total destruction depending upon the configuration of the structure, its distance from the epicenter, intensity of the earthquake and also on the founding soil strata present below the structure.

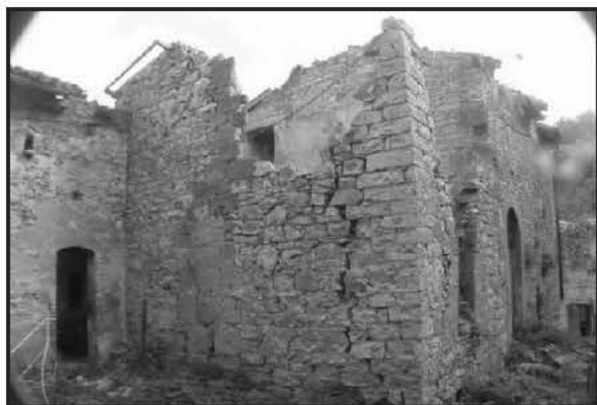
Fig. 18. Earthquake Affected Stone Masonry Structure
